**MULTIDISCIPLINARY ACCIDENT INVESTIGATION TEAM NARRATIVE/DIAGRAM**

**GS-067-24**

## MAIT SUPPLEMENTAL

**2024 Tesla Cybertruck**

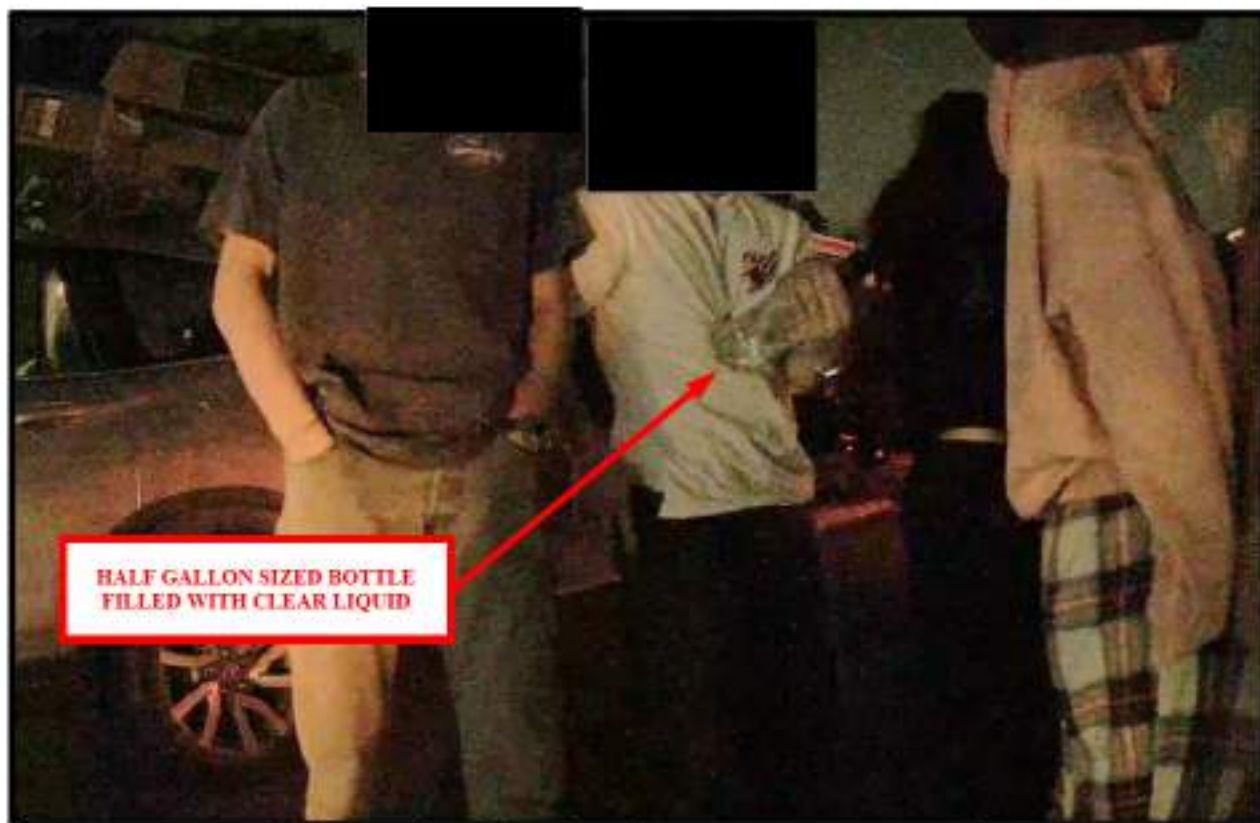
The Tesla Cybertruck backed to the east onto Somerset Road and pulled forward to the west next to a gray sport utility vehicle that was parked at the north curb. A young male wearing a dark short sleeved shirt walked toward the right side of the Tesla Cybertruck as a young female wearing a black sweatshirt and a young male wearing a white short sleeved shirt exited from the left rear door of the gray sport utility vehicle. A young female wearing a pink sweatshirt walked from the vicinity of the gray sport utility vehicle as all four pedestrians approached the right side of the Tesla Cybertruck. An arm extended out of the open right front passenger's window of the Tesla Cybertruck and shook the hand of the young female wearing the pink sweatshirt. The young male wearing the white short sleeved shirt was carrying a large half gallon sized bottle filled with a clear liquid.

*Lightened image clipped from the Right Repeater camera at 03:03:40 hours*

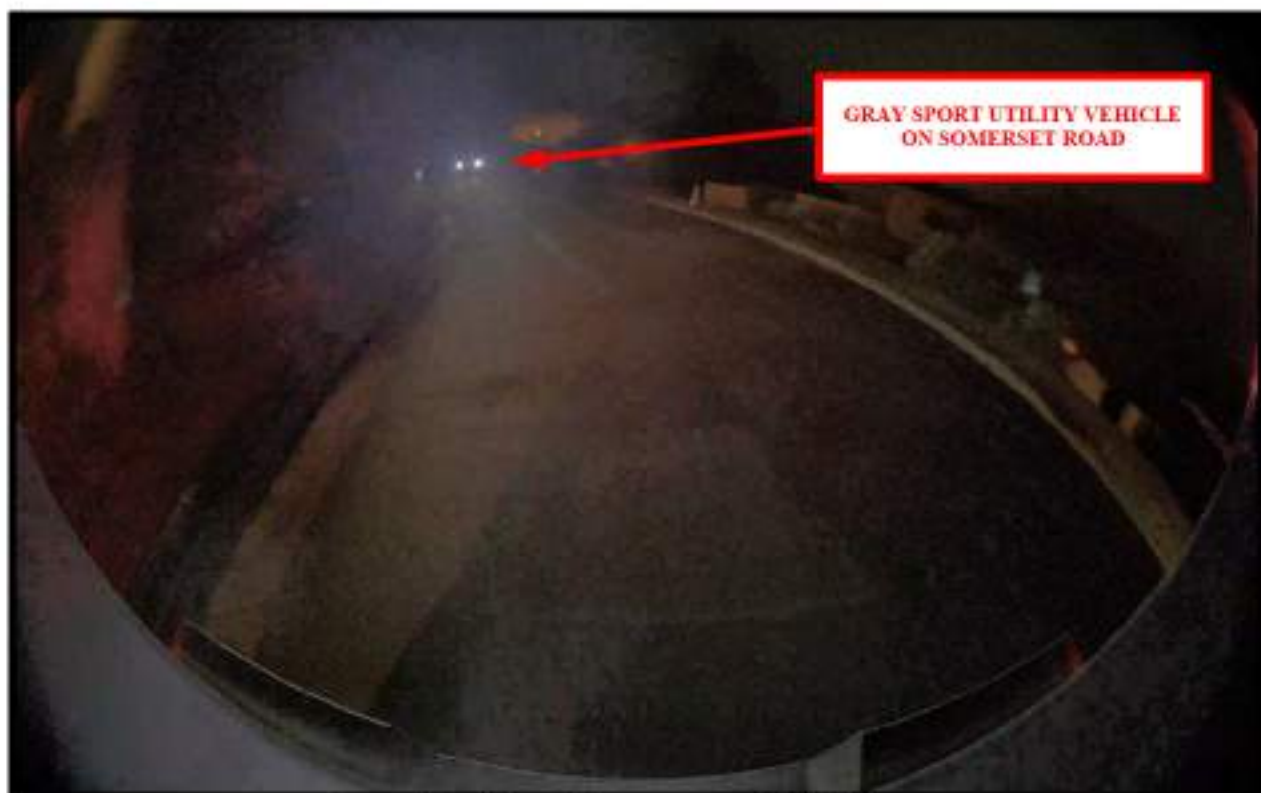
At approximately 03:04:26 hours, the right rear door of the Tesla Cybertruck was opened and the young male wearing the white short sleeved shirt entered the right rear seat while carrying the half gallon sized bottle filled with a clear liquid, followed by the young female wearing the black sweatshirt. The young male wearing the gray short sleeved shirt walked toward the driver's door of the gray sport utility vehicle as the young female wearing the pink sweatshirt walked toward the passenger side of the gray sport utility vehicle. The right rear passenger's door of the Tesla Cybertruck shut and moments later the Tesla Cybertruck drove west on Somerset Road followed by the gray sport utility vehicle.

*Image clipped from the Rear camera at 03:05:24 hours*
